Tray arm assembly (18596-60855)

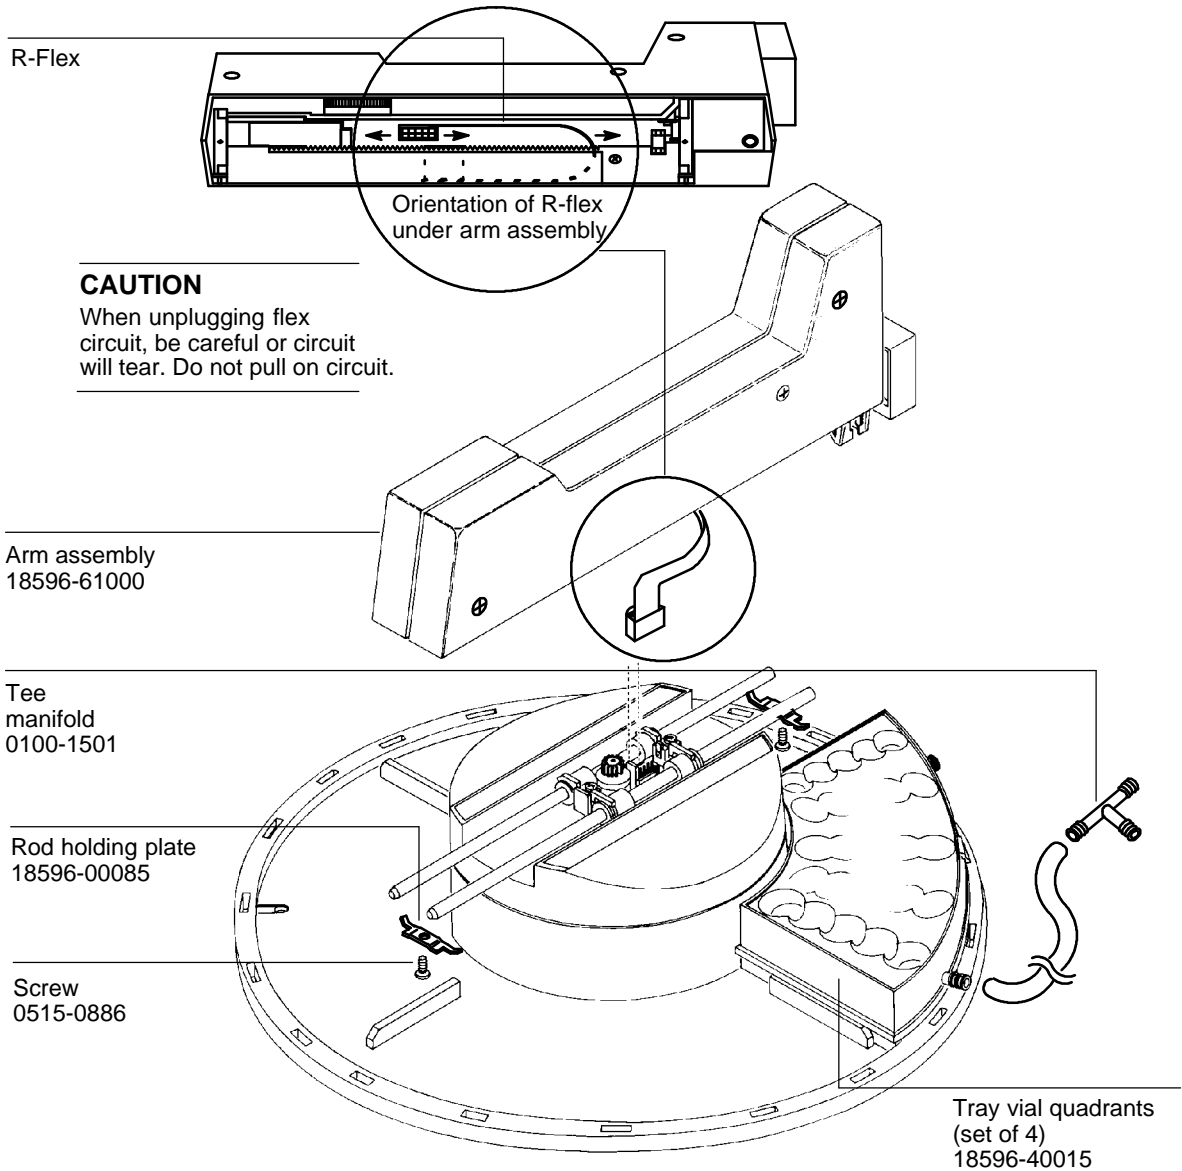
Figure 1030-8

Removing the tray arm assembly. See next page.
